# Access Compliance Report Public Rights-of-Way (Curb Ramps)

| Main Street: N_SELLAS_RD | | Cross Street: DELPHINIUM_ST | | Location: | NE |
| ADA ID: RPAT211102101629 | Ramp Type: Type 4 - Parallel | Initial Pass/Fail: Fail | Overall Compliance: No | Severity Score: | 15 |

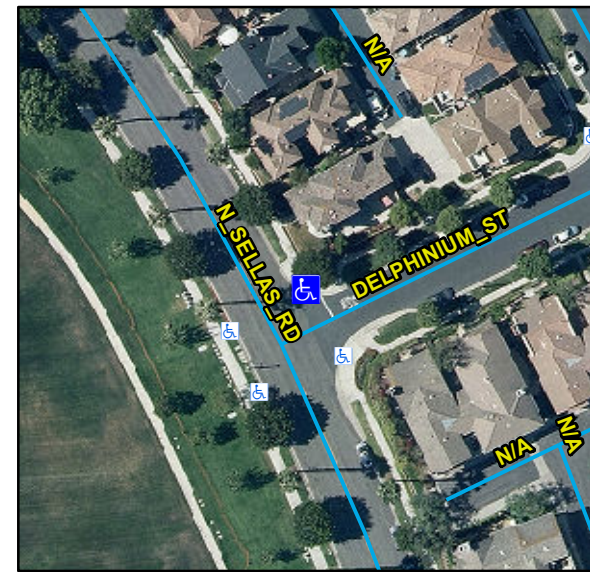
| Compliance | Description | Data | Compliance | Description | Data |
|---|---|---|---|---|---|
| Yes | Ramp Run Slope LT (%) | 1.8 | No | Ramp Run Slope RT (%) | 11.5 |

Possible Solutions:

**Remove & Replace Curb Ramp With Two New Directional Ramps or Equivalent.**

**R204.3, R304.3.2, STD 1115**

Total Cost: \$ 4000

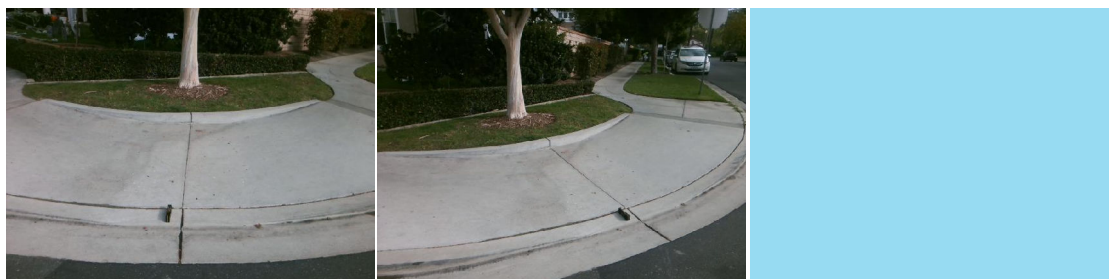
| Compliance | Description | Data | Compliance | Description | Data |
|---|---|---|---|---|---|
| N/A | Ramp Length LT (in) | 110 | N/A | Ramp Length RT (in) | 95 |
| Yes | Ramp Width LT (in) | 88 | Yes | Ramp Width RT (in) | 88 |
| Yes | Ramp Cross Slope LT (%) | 0.2 | Yes | Ramp Cross Slope RT (%) | 0.4 |
