# Access Compliance Report Public Rights-of-Way (Curb Ramps)

Main Street: DELPHINIUM\_ST Cross Street: N\_SELLAS\_RD Location: SE

ADA ID: RPAT211102101936 Ramp Type: Type 4 - Parallel Initial Pass/Fail: Fail Overall Compliance: No Severity Score: 2

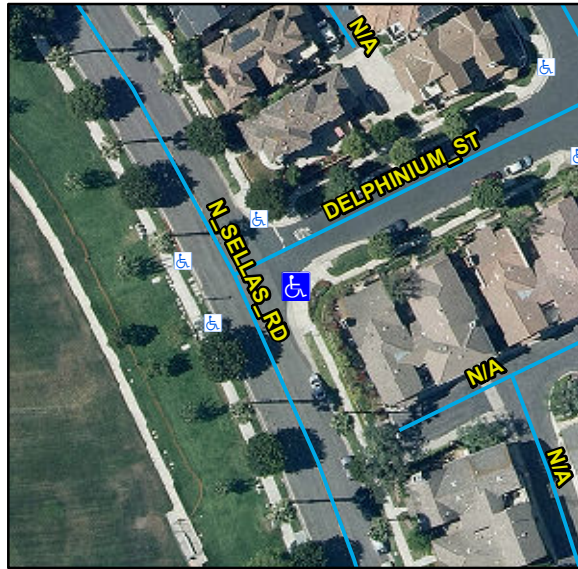
| Compliance | Description | Data | Compliance | Description | Data |
|---|---|---|---|---|---|
| Yes | Ramp Cross Slope LT (%) | 0.3 | No | Ramp Cross Slope RT (%) | 2.8 |

Remove & Replace Curb Ramp With Two New Directional Ramps or Equivalent.
