# Access Compliance Report Public Rights-of-Way (Curb Ramps)

| Main Street: N_SELLAS_RD | | Cross Street: N_SELLAS_RD | | Location: | SW |
| ADA ID: RPAT211102102417 | Ramp Type:Type 1 - Perpendicular | Initial Pass/Fail: Fail | Overall Compliance: No | Severity Score: | 32 |

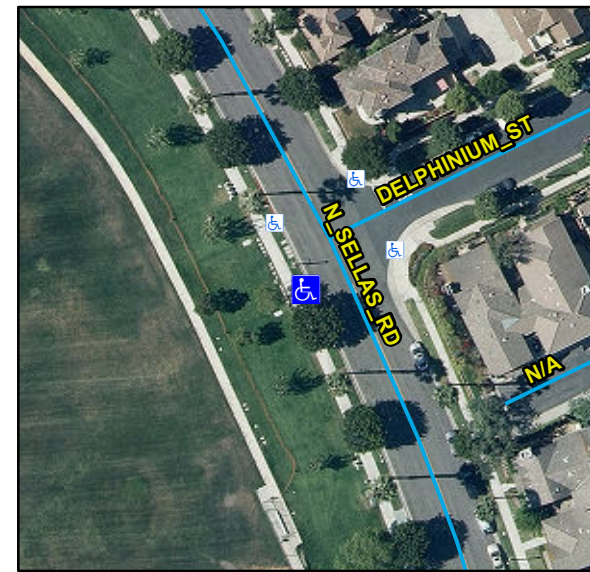
| Compliance | Description | Data | Compliance | Description | Data |
|---|---|---|---|---|---|
| No | Ramp Run Slope (%) | 12.3 | N/A | Flare Slope LT (%) | N/A |
| N/A | Gutter Ponding | N/A | No | Curb Slope | 10.1 |

Possible Solutions:

Remove & Replace Entire Ramp.

R304.2.2, R204.3, STD 1115
