# Access Compliance Report Public Rights-of-Way (Curb Ramps)

| Main Street: DELPHINIUM_ST | | Cross Street: TRUMPET_VINE_ST | | Location: | NW |
| ADA ID: RPAT211102103259 | Ramp Type: Type 4 - Parallel | Initial Pass/Fail: Fail | Overall Compliance: No | Severity Score: | 2 |

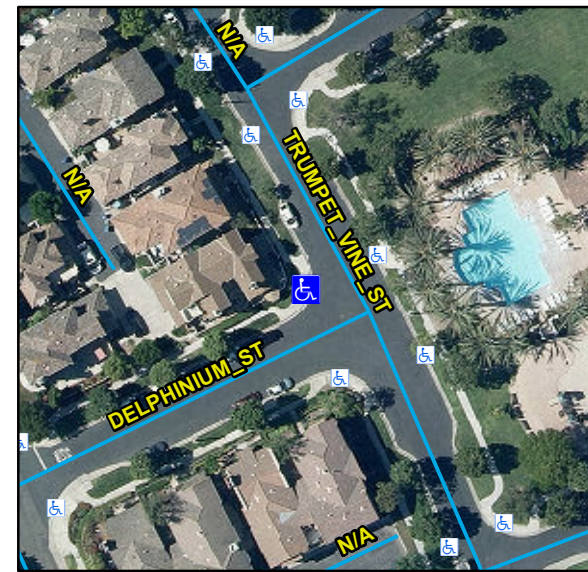
**R204.3, R304.5.3, STD 1115**

| Compliance | Description | Data | Compliance | Description | Data |
|---|---|---|---|---|---|
| No | Ramp Cross Slope LT (%) | 3.9 | No | Ramp Cross Slope RT (%) | 2.7 |

**Remove & Replace Curb Ramp With Two New Directional Ramps or Equivalent.**

Total Cost: \$ 4000

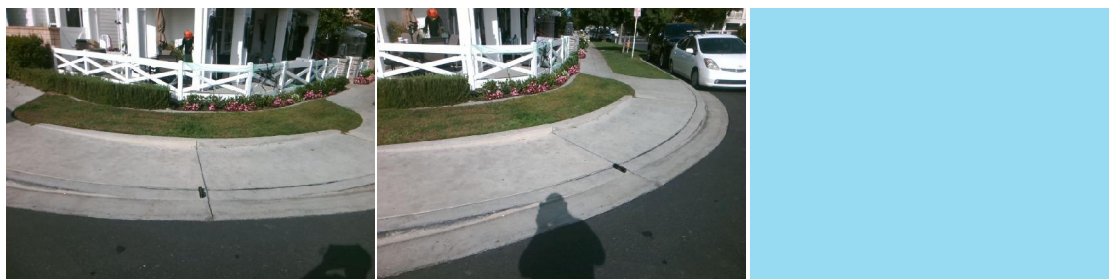
| Compliance | Description | Data | Compliance | Description | Data |
|---|---|---|---|---|---|
| N/A | Ramp Length LT (in) | 112 | N/A | Ramp Length RT (in) | 100 |
| Yes | Ramp Width LT (in) | 52 | Yes | Ramp Width RT (in) | 53 |
| Yes | Ramp Run Slope LT (%) | 4.3 | Yes | Ramp Run Slope RT (%) | 3.8 |
