# Access Compliance Report Public Rights-of-Way (Curb Ramps)

| Main Street: TRUMPET_VINE_ST | | Cross Street: DELPHINIUM_ST | | Location: | NE |
| ADA ID: RPAT211102103609 | Ramp Type:Type 1 - Perpendicular | Initial Pass/Fail: Fail | Overall Compliance: No | Severity Score: | 15 |

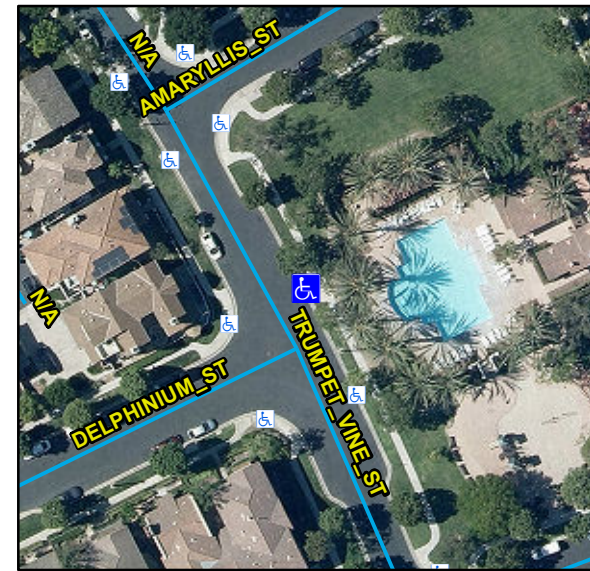
| Compliance | Description | Data | Compliance | Description | Data |
|---|---|---|---|---|---|
| No | Ramp Run Slope (%) | 8.4 | N/A | Flare Slope LT (%) | N/A |
| N/A | Gutter Ponding | N/A | No | Curb Slope | 13.6 |

Possible Solutions:

Remove & Replace Entire Ramp.

R304.2.2, R204.3, STD 1115

Total Cost: \$ 3080
