# Access Compliance Report Public Rights-of-Way (Curb Ramps)

| Main Street: AMARYLLIS_ST | | Cross Street: TRUMPET_VINE_ST | | Location: | SE |
| ADA ID: RPAT211102104054 | Ramp Type: Type 4 - Parallel | Initial Pass/Fail: Fail | Overall Compliance: No | Severity Score: | 2 |

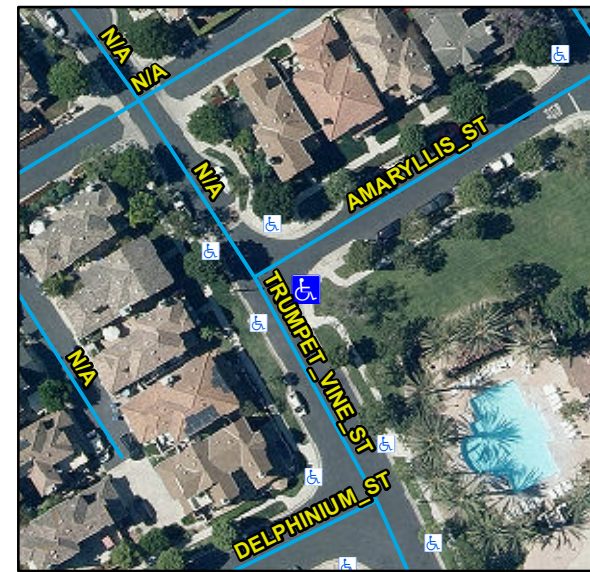
| Compliance | Description | Data | Compliance | Description | Data |
|---|---|---|---|---|---|
| Yes | Ramp Cross Slope LT (%) | 1.6 | No | Ramp Cross Slope RT (%) | 4.7 |

**Remove & Replace Curb Ramp With Two New Directional Ramps or Equivalent.**

**R204.3, R304.5.3, STD 1115**

Total Cost: \$ 4000
