# Access Compliance Report Public Rights-of-Way (Curb Ramps)

| Main Street: TRUMPET_VINE_ST | | Cross Street: AMARYLLIS_ST | | Location: | NE |
| ADA ID: RPAT211102104604 | Ramp Type: Type 4 - Parallel | Initial Pass/Fail: Fail | Overall Compliance: No | Severity Score: | 2 |

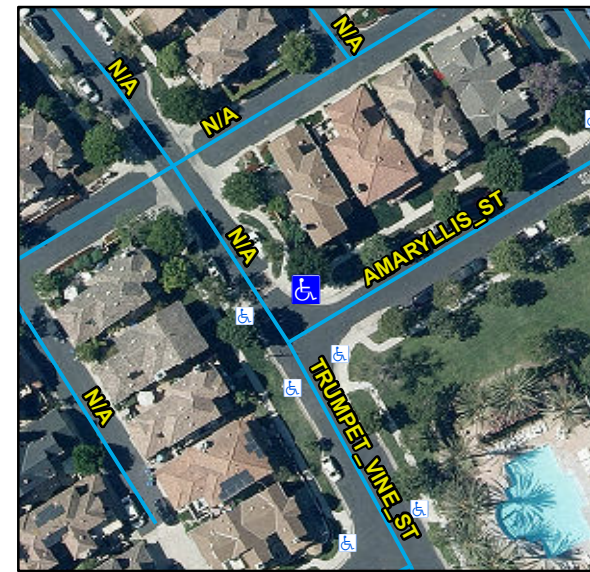
| Compliance | Description | Data | Compliance | Description | Data |
|---|---|---|---|---|---|
| No | Ramp Cross Slope LT (%) | 3.2 | Yes | Ramp Cross Slope RT (%) | 1.6 |

**Remove & Replace Curb Ramp With Two New Directional Ramps or Equivalent.**

**R204.3, R304.5.3, STD 1115**

Total Cost: \$ 4000
