# Access Compliance Report Public Rights-of-Way (Curb Ramps)

Main Street: SKLAR\_ST Cross Street: AMARYLLIS\_ST Location: SW

ADA ID: RPAT211102105014 Ramp Type: Type 4 - Parallel Initial Pass/Fail: Fail Overall Compliance: No Severity Score: 2

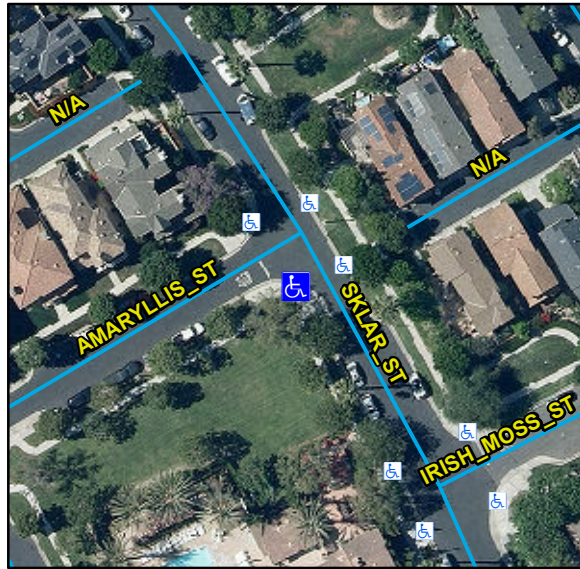
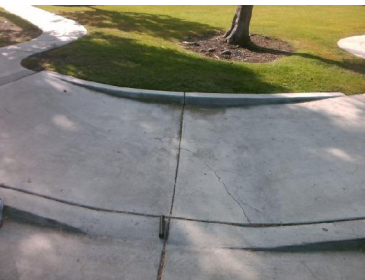
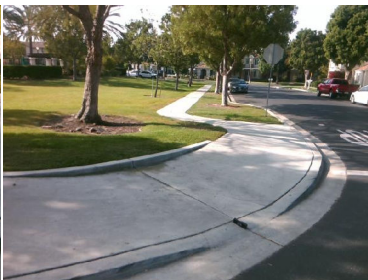
R304.2.2, R204.3, R304.5.3, STD 1115

| Compliance | Description | Data | Compliance | Description | Data |
|---|---|---|---|---|---|
| Yes | Ramp Cross Slope LT (%) | 1.7 | No | Ramp Cross Slope RT (%) | 2.3 |
| N/A | Gutter Ponding | N/A | No | Curb Slope | 11 |

Remove & Replace Curb Ramp With Two New Directional Ramps or Equivalent.
