# Access Compliance Report Public Rights-of-Way (Curb Ramps)

Main Street: AMARYLLIS\_ST Cross Street: SKLAR\_ST Location: NW

ADA ID: RPAT211102105403 Ramp Type: Type 4 - Parallel Initial Pass/Fail: Pass Overall Compliance: No Severity Score: 15

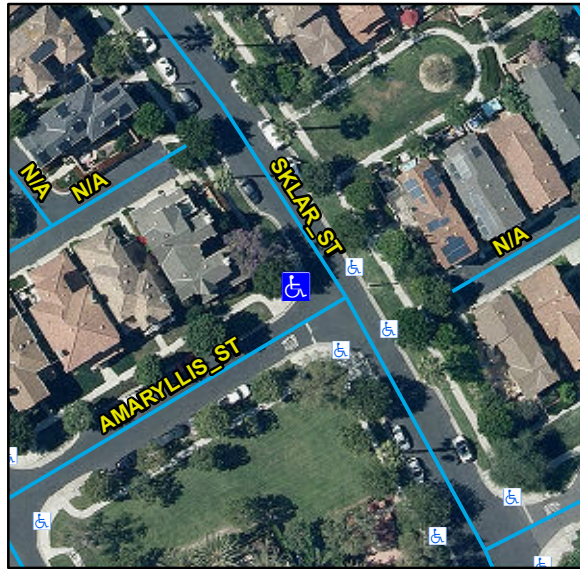
R304.2.2, R204.3, R305, R304.5.4, STD 1115

Remove & Replace Curb Ramp With Two New Directional Ramps or Equivalent. Remove & Replace Gutter.

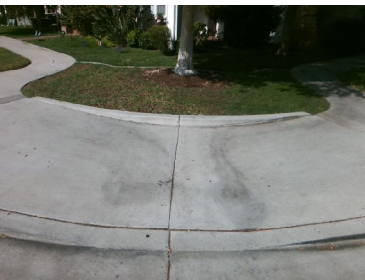
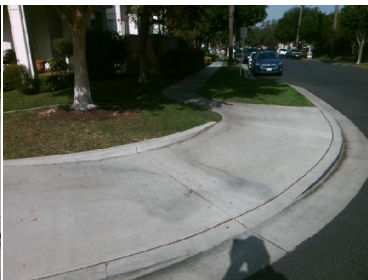
| Compliance | Description | Data | Compliance | Description | Data |
|---|---|---|---|---|---|
| N/A | Landing Present | Yes | No | DWS Provided | No |
| Yes | Gutter Ponding | No | No | Curb Slope | 13.5 |
| No | Gutter Run Slope (%) | 5.5 | | Road Cross Slope (%) | 2 |
| Yes | Gutter Cross Slope (%) | 0.3 | No | Perpendicular Joint Present | No |
