# Access Compliance Report Public Rights-of-Way (Curb Ramps)

| Main Street: IRISH_MOSS_ST | | Cross Street: SKLAR_ST | | Location: | SE |
| ADA ID: RPAT211102110639 | Ramp Type: Type 4 - Parallel | Initial Pass/Fail: Pass | Overall Compliance: No | Severity Score: | 15 |

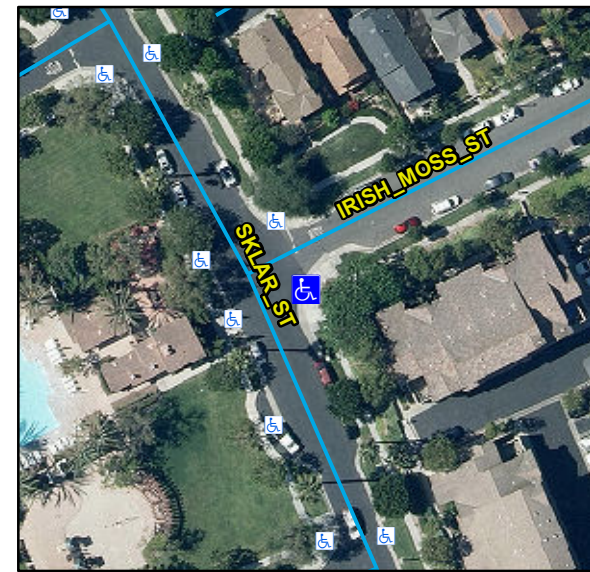
| Compliance | Description | Data | Compliance | Description | Data |
|---|---|---|---|---|---|
| N/A | Landing Present | Yes | No | DWS Provided | No |
| No | Gutter Run Slope (%) | 8.5 | | Road Cross Slope (%) | 1 |
| No | Gutter Cross Slope (%) | 3.5 | No | Perpendicular Joint Present | No |

Remove & Replace Curb Ramp With Two New Directional Ramps or Equivalent. Remove & Replace Gutter.
