| Main Street: SKLAR_ST | | Cross Street: IRISH_MOSS_ST | | Location: | SW |

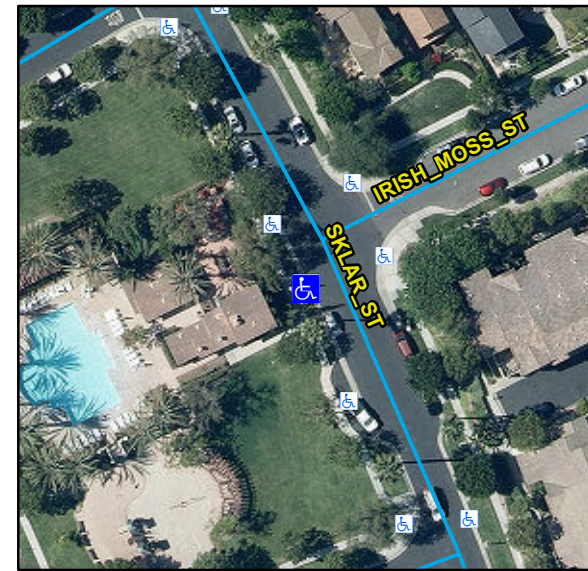
| ADA ID: RPAT211102111118 | Ramp Type:Type 1 - Perpendicular | Initial Pass/Fail: Pass | Overall Compliance: No | Severity Score: | 15 |

| Compliance | Description | Data | Compliance | Description | Data |
|---|---|---|---|---|---|
| Yes | Landing Cross Slope (%) | 1.3 | No | DWS Provided | No |
| No | Gutter Run Slope (%) | 11.8 | | Road Cross Slope (%) | N/A |

Remove & Replace Entire Ramp. Remove & Replace Gutter.

R304.2.1, R305, R304.5.4, STD 1115
