# Access Compliance Report Public Rights-of-Way (Curb Ramps)

Main Street: GLOXINIA\_ST Cross Street: SKLAR\_ST Location: NW

ADA ID: RPAT211102111525 Ramp Type: Type 1 - Perpendicular Diagonal Initial Pass/Fail: Pass Overall Compliance: No Severity Score: 25

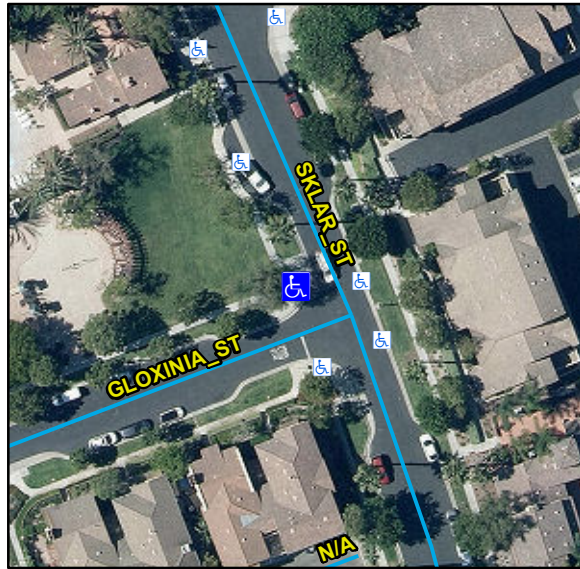
## Field Measurements/Component Compliance

| Compliance | Description | Data | Compliance | Description | Data |
|---|---|---|---|---|---|
| No | Landing Width (in) | N/A | Yes | Flare Slope RT (%) | 3.2 |
| No | Landing Run Slope (%) | N/A | N/A | Flare Traversable RT | Yes |
| No | Landing Cross Slope (%) | N/A | No | DWS Provided | No |
| Yes | Gutter Ponding | No | No | Curb Slope | 11.5 |
| No | Gutter Run Slope (%) | 9 | | Road Cross Slope (%) | 0.9 |

Remove & Replace Curb Ramp With Two New Directional Ramps or Equivalent. Remove & Replace Gutter.
