# Access Compliance Report Public Rights-of-Way (Curb Ramps)

Main Street: TRUMPET\_VINE\_ST Cross Street: GLOXINIA\_ST Location: NE

ADA ID: RPAT211102112717 Ramp Type: Type 4 - Parallel Initial Pass/Fail: Fail Overall Compliance: No Severity Score: 2

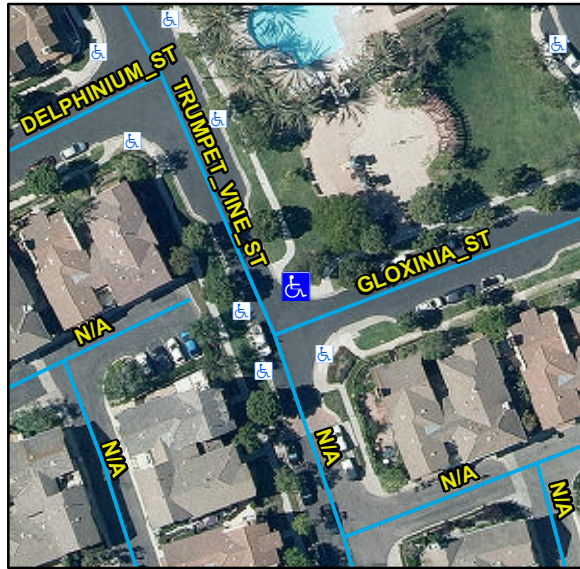
| Compliance | Description | Data | Compliance | Description | Data |
|---|---|---|---|---|---|
| N/A | Ramp Length LT (in) | 104 | N/A | Ramp Length RT (in) | 100 |
| Yes | Ramp Width LT (in) | 53 | Yes | Ramp Width RT (in) | 53 |
| Yes | Ramp Run Slope LT (%) | 5.3 | Yes | Ramp Run Slope RT (%) | 6.6 |
| No | Ramp Cross Slope LT (%) | 3.1 | Yes | Ramp Cross Slope RT (%) | 1.8 |

Remove & Replace Curb Ramp With Two New Directional Ramps or Equivalent.

R204.3, R304.5.3, STD 1115

Total Cost: \$ 4000
