# Access Compliance Report Public Rights-of-Way (Curb Ramps)

Main Street: GLOXINIA\_ST Cross Street: N/A Location: SE

ADA ID: RPAT211102113113 Ramp Type: Type 4 - Parallel Initial Pass/Fail: Fail Overall Compliance: No Severity Score: 2

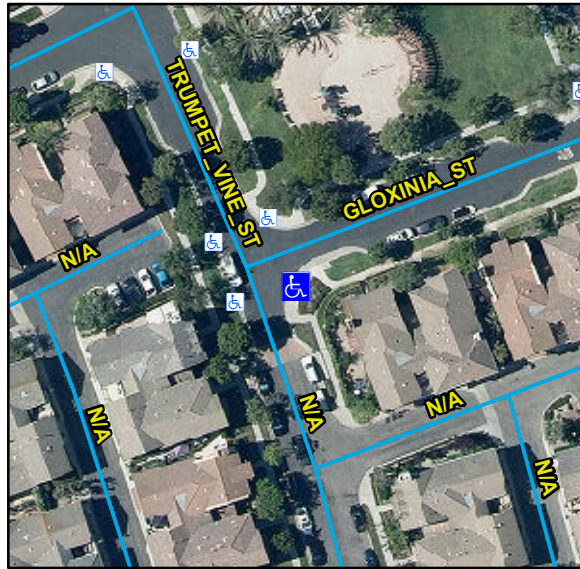
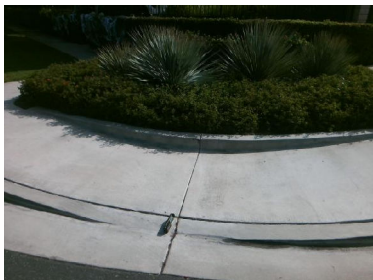
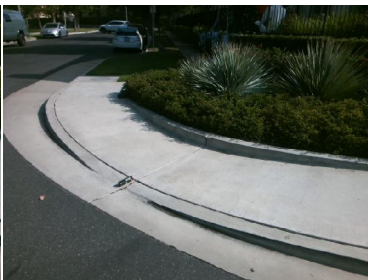
| Compliance | Description | Data | Compliance | Description | Data |
|---|---|---|---|---|---|
| Yes | Ramp Cross Slope LT (%) | 1.5 | No | Ramp Cross Slope RT (%) | 2.5 |
| N/A | Gutter Cross Slope (%) | N/A | No | Perpendicular Joint Present | No |

Remove & Replace Curb Ramp With Two New Directional Ramps or Equivalent.

R204.3, R304.5.3, STD 1115

Total Cost: \$ 4000
