# Access Compliance Report Public Rights-of-Way (Curb Ramps)

Main Street: S\_SELLAS\_RD Cross Street: HYDRANGEA\_ST Location: SE

ADA ID: RPAT211102131601 Ramp Type: Type 4 - Parallel Initial Pass/Fail: Pass Overall Compliance: No Severity Score: 16

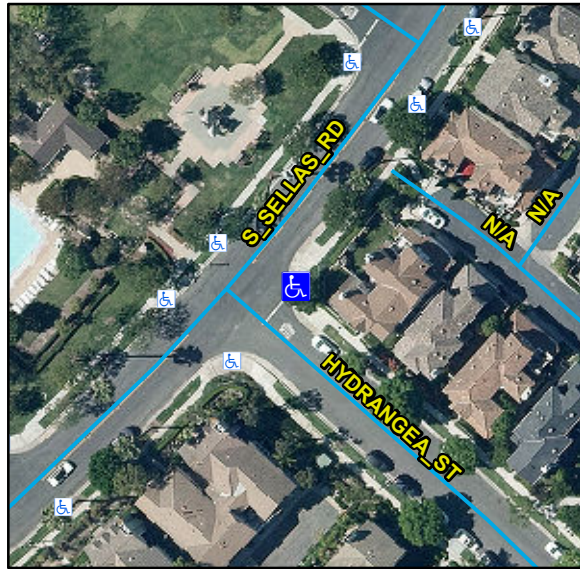
| Compliance | Description | Data | Compliance | Description | Data |
|---|---|---|---|---|---|
| N/A | Landing Present | Yes | No | DWS Provided | No |
| No | Landing Run Slope (%) | 2.1 | N/A | DWS Full Width | N/A |
| No | Landing Cross Slope (%) | 2.2 | | DWS Offset Type | N/A |
| Yes | Gutter Ponding | No | No | Curb Slope | 9.7 |
| No | Gutter Run Slope (%) | 7.2 | | Road Cross Slope (%) | 0.6 |

Remove & Replace Curb Ramp With Two New Directional Ramps or Equivalent. Remove & Replace Gutter.
