# Access Compliance Report Public Rights-of-Way (Curb Ramps)

| Main Street: TRISTANIA_ST | | Cross Street: S_SELLAS_RD | | Location: | NE |
| ADA ID: RPAT211102132538 | Ramp Type: Type 4 - Parallel | Initial Pass/Fail: Fail | Overall Compliance: No | Severity Score: | 2 |

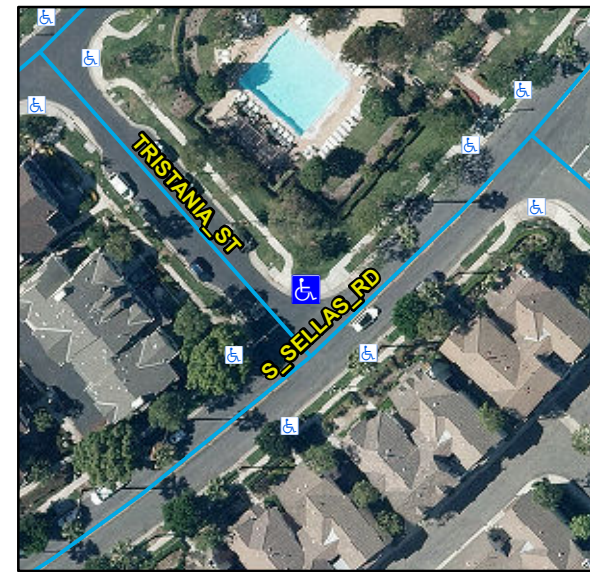
| Compliance | Description | Data | Compliance | Description | Data |
|---|---|---|---|---|---|
| Yes | Ramp Run Slope LT (%) | 4.5 | Yes | Ramp Run Slope RT (%) | 6.2 |
| No | Ramp Cross Slope LT (%) | 4.8 | No | Ramp Cross Slope RT (%) | 2.2 |

**Remove & Replace Curb Ramp With Two New Directional Ramps or Equivalent.**

**R204.3, R304.5.3, STD 1115**

Total Cost: \$ 4000
