# Access Compliance Report Public Rights-of-Way (Curb Ramps)

Main Street: S\_SELLAS\_RD Cross Street: TRISTANIA\_ST Location: NW

ADA ID: RPAT211102132855 Ramp Type: Type 1 - Perpendicular Diagonal Initial Pass/Fail: Fail Overall Compliance: No Severity Score: 2

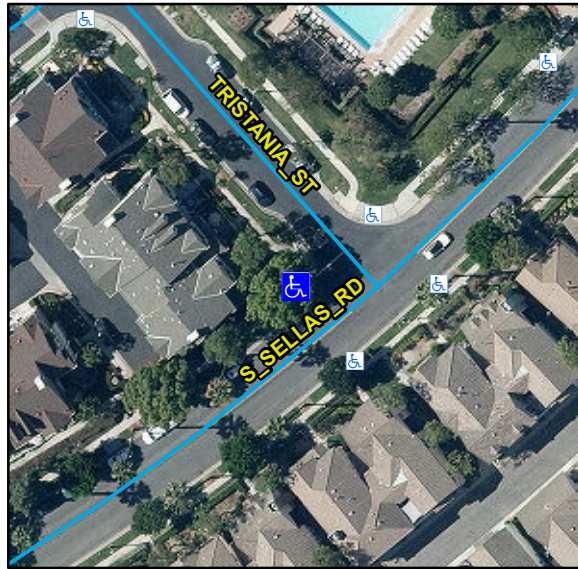
| Compliance | Description | Data | Compliance | Description | Data |
|---|---|---|---|---|---|
| No | Ramp Cross Slope (%) | 4.5 | N/A | Flare Traversable LT | N/A |

Remove & Replace Curb Ramp With Two New Directional Ramps or Equivalent.

R204.3, R304.5.3, STD 1115
