# Access Compliance Report Public Rights-of-Way (Curb Ramps)

Main Street: TRISTANIA\_ST Cross Street: STRAWFLOWER\_ST Location: SW

ADA ID: RPAT211102133350 Ramp Type: Type 4 - Parallel Initial Pass/Fail: Fail Overall Compliance: No Severity Score: 2

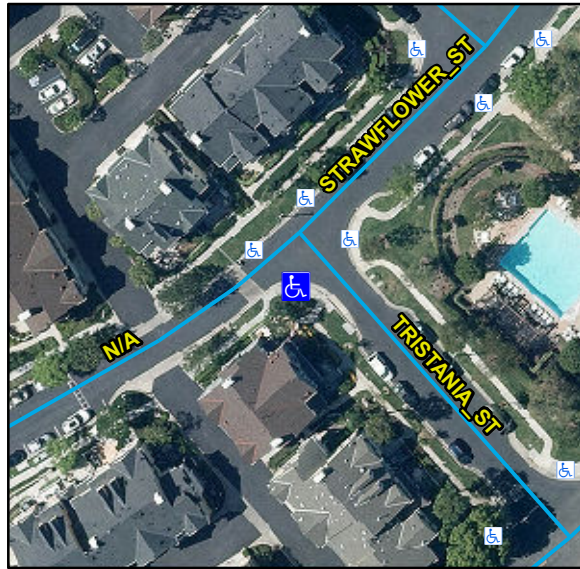
| Compliance | Description | Data | Compliance | Description | Data |
|---|---|---|---|---|---|
| No | Ramp Cross Slope LT (%) | 2.3 | No | Ramp Cross Slope RT (%) | 3.1 |

**Remove & Replace Curb Ramp With Two New Directional Ramps or Equivalent.**

**R204.3, R304.5.3, STD 1115**
