# Access Compliance Report Public Rights-of-Way (Curb Ramps)

| Main Street: STRAWFLOWER_ST | Cross Street: TRISTANIA_ST | Location: SE |

| ADA ID: RPAT211102133851 | Ramp Type: Type 4 - Parallel | Initial Pass/Fail: Fail | Overall Compliance: No | Severity Score: 2 |

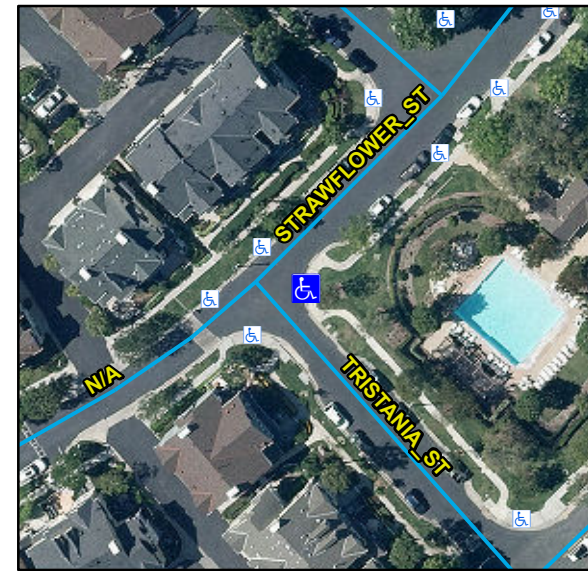
| Compliance | Description | Data | Compliance | Description | Data |
|---|---|---|---|---|---|
| No | Ramp Cross Slope LT (%) | 3 | No | Ramp Cross Slope RT (%) | 3.3 |

Possible Solutions:  
**Remove & Replace Curb Ramp With Two New Directional Ramps or Equivalent.**

OC Std/PROW:  
**R204.3, R304.5.3, STD 1115**

Total Cost: \$ 4000

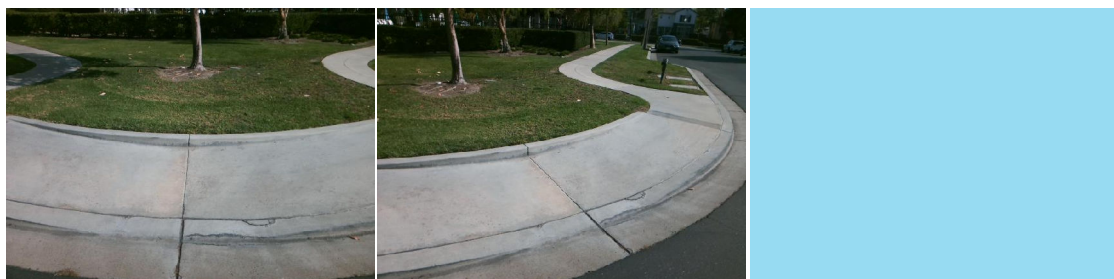
| Compliance | Description | Data | Compliance | Description | Data |
| N/A | Ramp Length LT (in) | 120 | N/A | Ramp Length RT (in) | 110 |
| Yes | Ramp Width LT (in) | 52 | Yes | Ramp Width RT (in) | 52 |
| Yes | Ramp Run Slope LT (%) | 1.9 | Yes | Ramp Run Slope RT (%) | 5.2 |
