# Access Compliance Report Public Rights-of-Way (Curb Ramps)

| Main Street: STRAWFLOWER_ST | | Cross Street: GILLY_FLOWER_ST | | Location: | NW |
| ADA ID: RPAT211102134244 | Ramp Type: Type 4 - Parallel | Initial Pass/Fail: Fail | Overall Compliance: No | Severity Score: | 15 |

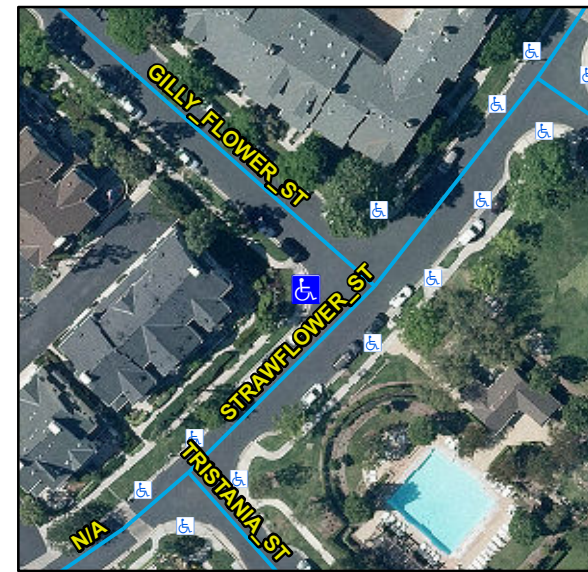
| Compliance | Description | Data | Compliance | Description | Data |
|---|---|---|---|---|---|
| Yes | Ramp Run Slope LT (%) | 5.5 | Yes | Ramp Run Slope RT (%) | 1.4 |
| No | Ramp Cross Slope LT (%) | 5.1 | No | Ramp Cross Slope RT (%) | 3.8 |

**Remove & Replace Curb Ramp With Two New Directional Ramps or Equivalent.**

**R204.3, R304.5.3, STD 1115**

Total Cost: \$ 4000
