# Access Compliance Report Public Rights-of-Way (Curb Ramps)

| Main Street: GILLY_FLOWER_ST | | Cross Street: STRAWFLOWER_ST | | Location: | NE |
| ADA ID: RPAT211102134856 | Ramp Type: Type 4 - Parallel | Initial Pass/Fail: Fail | Overall Compliance: No | Severity Score: | 16 |

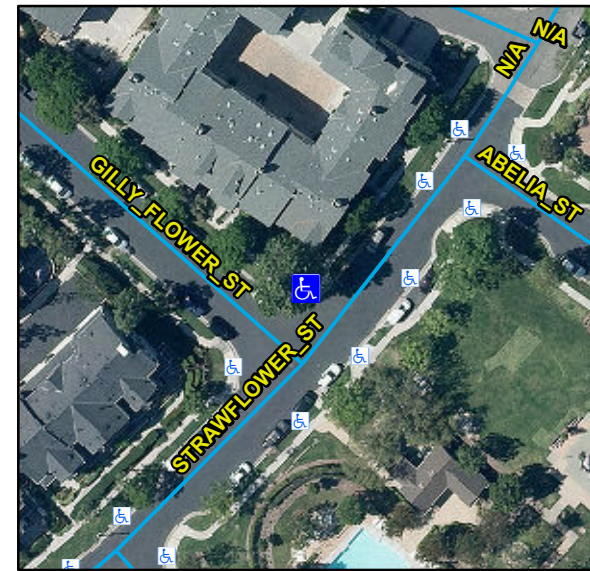
| Compliance | Description | Data | Compliance | Description | Data |
|---|---|---|---|---|---|
| Yes | Ramp Run Slope LT (%) | 1.5 | No | Ramp Run Slope RT (%) | 9.1 |
| No | Ramp Cross Slope LT (%) | 4.5 | No | Ramp Cross Slope RT (%) | 2.6 |

**Remove & Replace Curb Ramp With Two New Directional Ramps or Equivalent.**

**R204.3, R304.5.3, R304.3.2, STD 1115**

Total Cost: \$ 4000

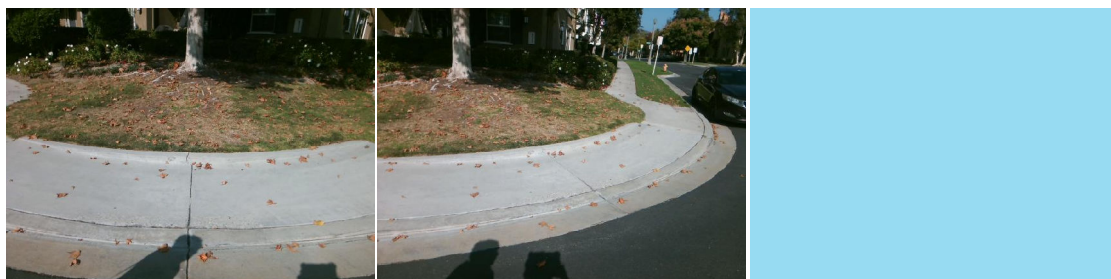
| Compliance | Description | Data | Compliance | Description | Data |
|---|---|---|---|---|---|
| N/A | Ramp Length LT (in) | 110 | N/A | Ramp Length RT (in) | 100 |
| Yes | Ramp Width LT (in) | 53 | Yes | Ramp Width RT (in) | 53 |
