# Access Compliance Report Public Rights-of-Way (Curb Ramps)

| Main Street: ABELIA_ST | | Cross Street: STRAWFLOWER_ST | | Location: | S |
| ADA ID: RPAT211102135612 | Ramp Type: Type 4 - Parallel | Initial Pass/Fail: Fail | Overall Compliance: No | Severity Score: | 16 |

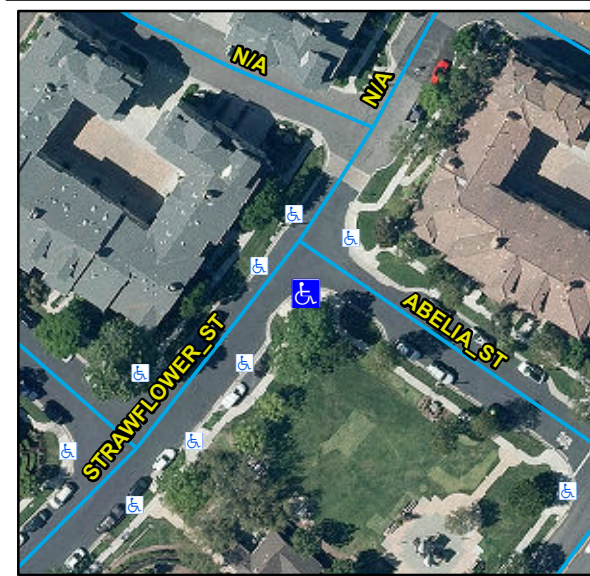
| Compliance | Description | Data | Compliance | Description | Data |
|---|---|---|---|---|---|
| No | Ramp Run Slope LT (%) | 10 | Yes | Ramp Run Slope RT (%) | 1.4 |
| No | Ramp Cross Slope LT (%) | 2.8 | No | Ramp Cross Slope RT (%) | 2.3 |

**Remove & Replace Curb Ramp With Two New Directional Ramps or Equivalent.**

**R204.3, R304.3.2, R304.5.3, STD 1115**
