# Access Compliance Report Public Rights-of-Way (Curb Ramps)

Main Street: STRAWFLOWER\_ST Cross Street: ABELIA\_ST Location: SE

ADA ID: RPAT211102140126 Ramp Type: Type 4 - Parallel Initial Pass/Fail: Pass Overall Compliance: No Severity Score: 10

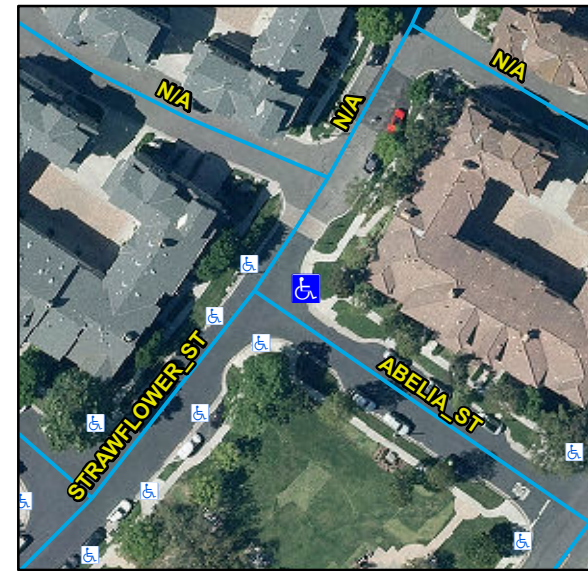
| Compliance | Description | Data | Compliance | Description | Data |
|---|---|---|---|---|---|
| N/A | Landing Present | Yes | No | DWS Provided | No |

Remove & Replace Curb Ramp With Two New Directional Ramps or Equivalent.

R204.3, R305, STD 1115
