# Access Compliance Report Public Rights-of-Way (Curb Ramps)

| Main Street: S_SELLAS_RD | | Cross Street: ABELIA_ST | | Location: | NW |
| ADA ID: RPAT211102140739 | Ramp Type: Type 4 - Parallel | Initial Pass/Fail: Fail | Overall Compliance: No | Severity Score: | 15 |

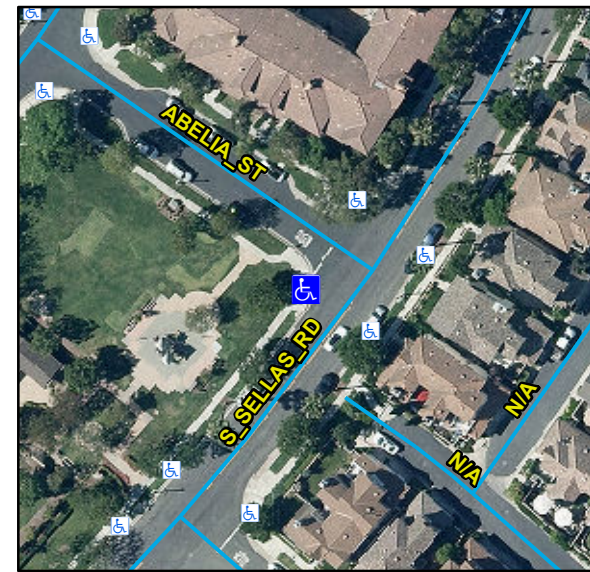
| Compliance | Description | Data | Compliance | Description | Data |
|---|---|---|---|---|---|
| Yes | Ramp Run Slope LT (%) | 3 | No | Ramp Run Slope RT (%) | 9.7 |

Possible Solutions:

**Remove & Replace Curb Ramp With Two New Directional Ramps or Equivalent.**

**R204.3, R304.3.2, STD 1115**

Total Cost: \$ 4000
