# Access Compliance Report Public Rights-of-Way (Curb Ramps)

Main Street: ABELIA\_ST Cross Street: S\_SELLAS\_RD Location: NE

ADA ID: RPAT211102141058 Ramp Type: Type 1 - Perpendicular Diagonal Initial Pass/Fail: Fail Overall Compliance: No Severity Score: 2

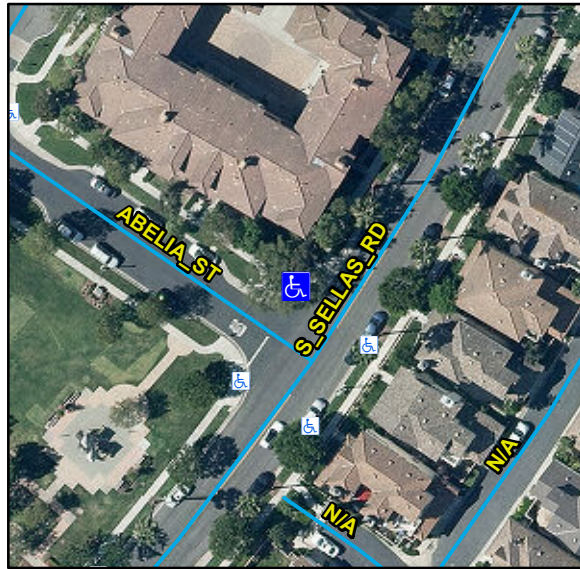
| Compliance | Description | Data | Compliance | Description | Data |
|---|---|---|---|---|---|
| No | Ramp Cross Slope (%) | 2.4 | N/A | Flare Traversable LT | N/A |
| N/A | Gutter Ponding | N/A | No | Curb Slope | 7.4 |

Remove & Replace Curb Ramp With Two New Directional Ramps or Equivalent.

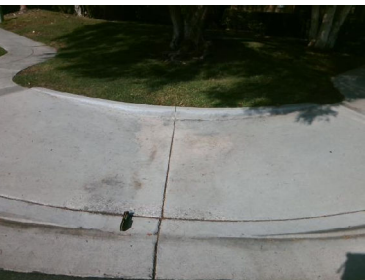
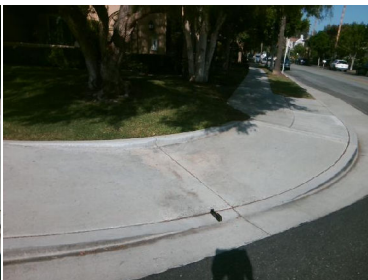
| Compliance | Description | Data | Compliance | Description | Data |
|---|---|---|---|---|---|
| Yes | Overall Surface Condition: Acceptable | | No | Perp Joint Present | No |
