# Access Compliance Report Public Rights-of-Way (Curb Ramps)

Main Street: **SACHEM\_WAY** Cross Street: **BARBERRY\_ST** Location: **SW**

ADA ID: **RPAT211102150029** Ramp Type: **Type 1 - Perpendicular Diagonal** Initial Pass/Fail: **Fail** Overall Compliance: **No** Severity Score: **30**

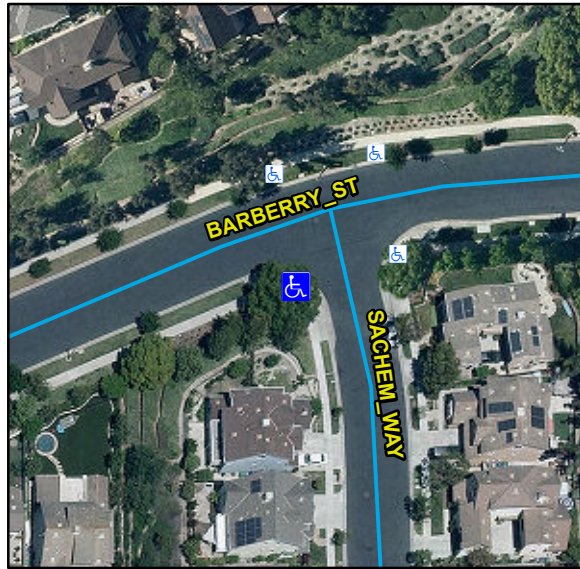
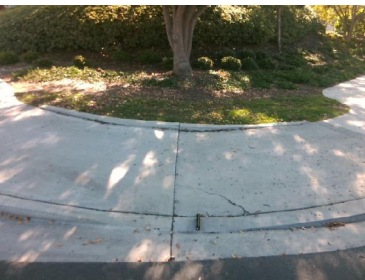
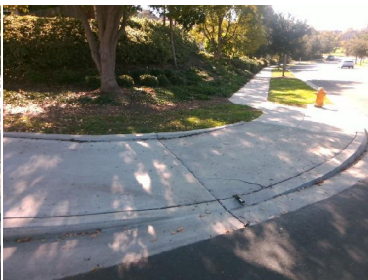
| Compliance | Description | Data | Compliance | Description | Data |
|---|---|---|---|---|---|
| <b>Yes</b> | Ramp Width (in) | <b>48</b> | | | <b>N/A</b> |
| <b>Yes</b> | Ramp Run Slope (%) | <b>6.5</b> | <b>N/A</b> | Flare Slope LT (%) | <b>N/A</b> |
| <b>No</b> | Ramp Cross Slope (%) | <b>8.1</b> | <b>N/A</b> | Flare Traversable LT | <b>N/A</b> |

**Remove & Replace Curb Ramp With Two New Directional Ramps or Equivalent.**
