# Access Compliance Report Public Rights-of-Way (Curb Ramps)

Main Street: BARBERRY\_ST Cross Street: SACHEM\_WAY Location: SE

ADA ID: RPAT211102150250 Ramp Type: Type 1 - Perpendicular Diagonal Initial Pass/Fail: Fail Overall Compliance: No Severity Score: 15

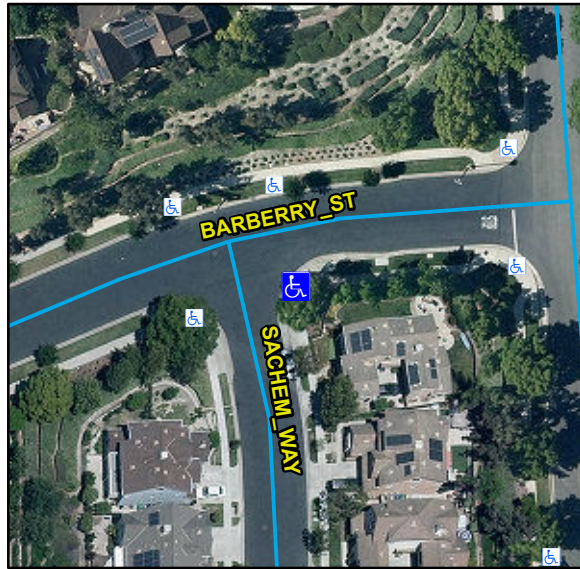
| Compliance | Description | Data | Compliance | Description | Data |
|---|---|---|---|---|---|
| No | Ramp Run Slope (%) | 9.5 | N/A | Flare Slope LT (%) | N/A |

Remove & Replace Curb Ramp With Two New Directional Ramps or Equivalent.

R304.2.2, R204.3, STD 1115
