# Access Compliance Report Public Rights-of-Way (Curb Ramps)

Main Street: HYDRANGEA\_ST Cross Street: BARBERRY\_ST Location: SW

ADA ID: RPAT211102150701 Ramp Type: Type 1 - Perpendicular Diagonal Initial Pass/Fail: Fail Overall Compliance: No Severity Score: 30

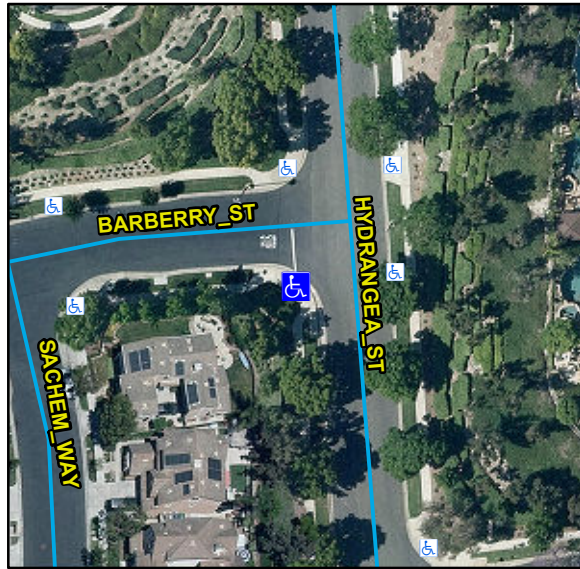
| Compliance | Description | Data | Compliance | Description | Data |
|---|---|---|---|---|---|
| No | Ramp Cross Slope (%) | 8.7 | N/A | Flare Traversable LT | N/A |

Remove & Replace Curb Ramp With Two New Directional Ramps or Equivalent.

R304.2.2, R204.3, R304.5.3, STD 1115
