# Access Compliance Report Public Rights-of-Way (Curb Ramps)

Main Street: BARBERRY\_ST Cross Street: HYDRANGEA\_ST Location: NW

ADA ID: RPAT211102150957 Ramp Type: Type 1 - Perpendicular Diagonal Initial Pass/Fail: Fail Overall Compliance: No Severity Score: 15

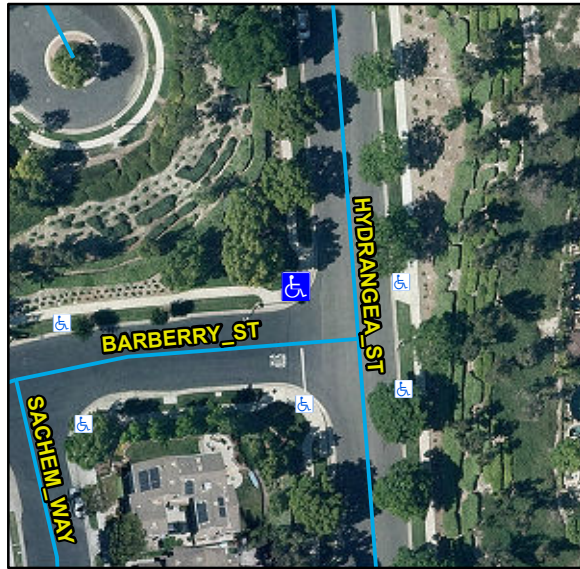
| Compliance | Description | Data | Compliance | Description | Data |
|---|---|---|---|---|---|
| No | Ramp Cross Slope (%) | 5.1 | N/A | Flare Traversable LT | N/A |

Remove & Replace Curb Ramp With Two New Directional Ramps or Equivalent.
