# Access Compliance Report Public Rights-of-Way (Curb Ramps)

| Main Street: HYDRANGEA_ST | | Cross Street: BARBERRY_ST | | Location: | NE |
| ADA ID: RPAT211102151157 | Ramp Type:Type 1 - Perpendicular | Initial Pass/Fail: Pass | Overall Compliance: No | Severity Score: | 35 |

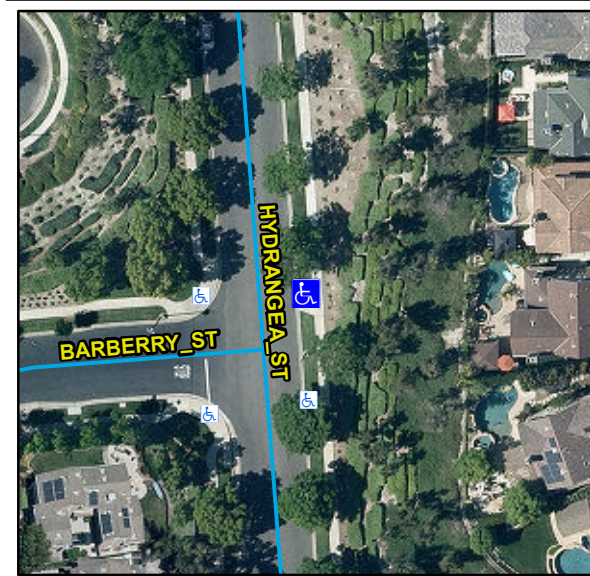
| Compliance | Description | Data | Compliance | Description | Data |
|---|---|---|---|---|---|
| No | Ramp Cross Slope (%) | 5.5 | N/A | Flare Traversable LT | No |
| No | Landing Cross Slope (%) | 6 | No | DWS Provided | No |
| Yes | Gutter Ponding | No | No | Curb Slope | 6.7 |
| No | Gutter Run Slope (%) | 11.2 | | Road Cross Slope (%) | N/A |
| No | Gutter Cross Slope (%) | 6.5 | | | |

Possible Solutions:  
**Remove & Replace Entire Ramp. Remove & Replace Gutter.**

OC Std/PROW:  
**R304.2.2, R304.5.3, R305, R304.5.4, STD 1115**

Total Cost: \$ 3332
