# Access Compliance Report Public Rights-of-Way (Curb Ramps)

Main Street: HYDRANGEA\_ST Cross Street: SMOKE\_TREE\_DR Location: NE

ADA ID: RPAT211102151614 Ramp Type: Type 1 - Perpendicular Diagonal Initial Pass/Fail: Fail Overall Compliance: No Severity Score: 30

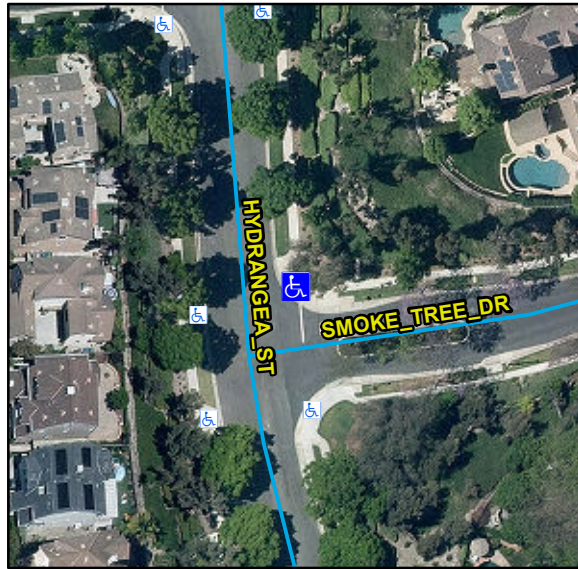
| Compliance | Description | Data | Compliance | Description | Data |
|---|---|---|---|---|---|
| No | Ramp Cross Slope (%) | 9.8 | N/A | Flare Traversable LT | N/A |

**Remove & Replace Curb Ramp With Two New Directional Ramps or Equivalent.**

**R204.3, R304.5.3, STD 1115**
