# Access Compliance Report Public Rights-of-Way (Curb Ramps)

Main Street: SMOKE\_TREE\_DR Cross Street: HYDRANGEA\_ST Location: SE

ADA ID: RPAT211102151852 Ramp Type: Type 4 - Parallel Initial Pass/Fail: Fail Overall Compliance: No Severity Score: 16

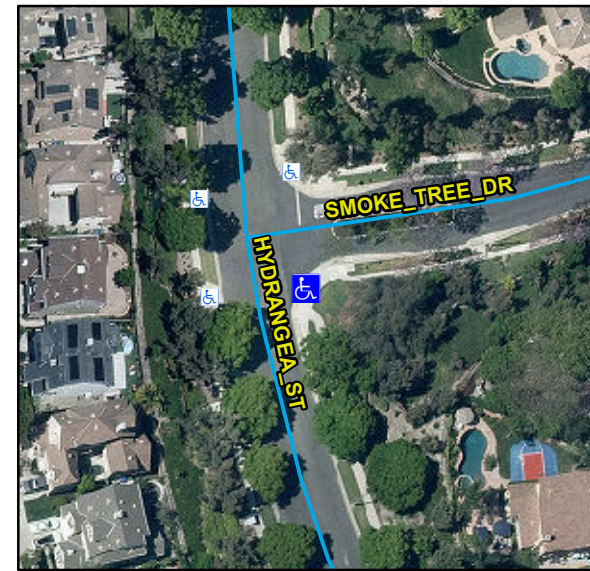
| Compliance | Description | Data | Compliance | Description | Data |
|---|---|---|---|---|---|
| Yes | Ramp Run Slope LT (%) | 0.1 | No | Ramp Run Slope RT (%) | 9.1 |
| Yes | Ramp Cross Slope LT (%) | 1.6 | No | Ramp Cross Slope RT (%) | 3.1 |

Remove & Replace Curb Ramp With Two New Directional Ramps or Equivalent.
