# Access Compliance Report Public Rights-of-Way (Curb Ramps)

Main Street: HYDRANGEA\_ST Cross Street: SMOKE\_TREE\_DR Location: SW

ADA ID: RPAT211102152113 Ramp Type: Type 1 - Perpendicular Initial Pass/Fail: Pass Overall Compliance: No Severity Score: 35

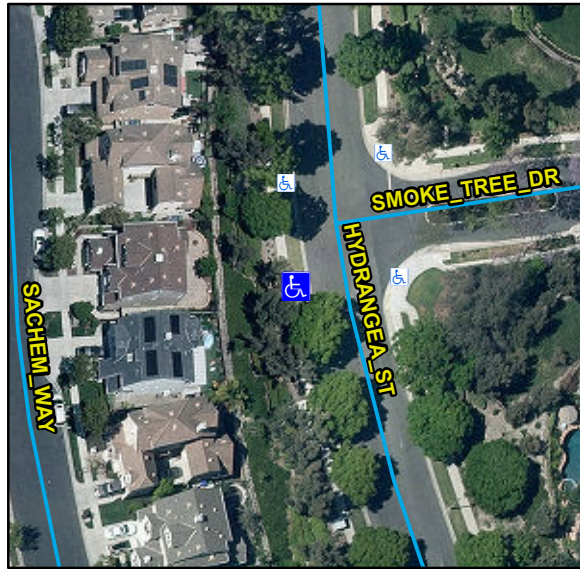
| Compliance | Description | Data | Compliance | Description | Data |
|---|---|---|---|---|---|
| No | Ramp Cross Slope (%) | 5.7 | N/A | Flare Traversable LT | No |
| No | Landing Cross Slope (%) | 7 | No | DWS Provided | No |
| No | Gutter Run Slope (%) | 12 | | Road Cross Slope (%) | N/A |
| No | Gutter Cross Slope (%) | 8.3 | | | |

Remove & Replace Entire Ramp. Remove & Replace Gutter.

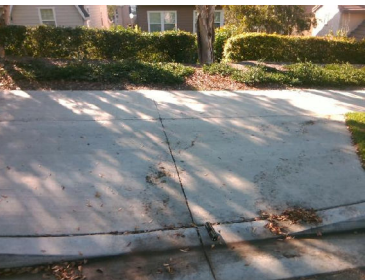
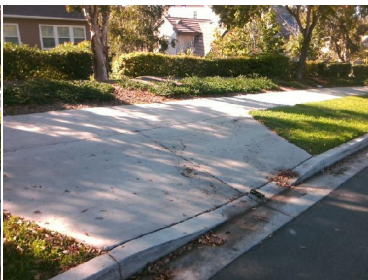
| Compliance | Description | Data | Compliance | Description | Data |
|---|---|---|---|---|---|
| Yes | Overall Surface Condition: Acceptable | | Yes | Perp Joint Present | Yes |
