# Access Compliance Report Public Rights-of-Way (Curb Ramps)

| Main Street: SCARLET_MAPLE_DR | | Cross Street: SMOKE_TREE_DR | | Location: | SW |
| ADA ID: RPAT211102152812 | Ramp Type: Type 4 - Parallel | Initial Pass/Fail: Fail | Overall Compliance: No | Severity Score: | 32 |

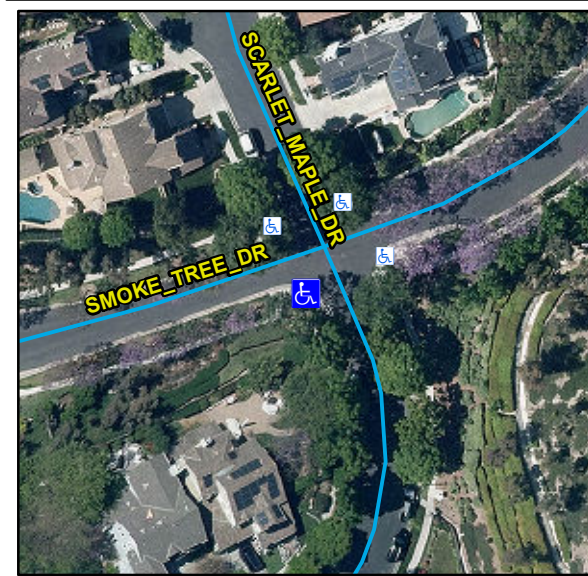
| Compliance | Description | Data | Compliance | Description | Data |
|---|---|---|---|---|---|
| No | Ramp Run Slope LT (%) | 13.1 | Yes | Ramp Run Slope RT (%) | 2.3 |
| No | Ramp Cross Slope LT (%) | 2.2 | Yes | Ramp Cross Slope RT (%) | 0.1 |

Possible Solutions:

**Remove & Replace Curb Ramp With Two New Directional Ramps or Equivalent.**

**R204.3, R304.3.2, R304.5.3, STD 1115**

Total Cost: \$ 4000
