# Access Compliance Report Public Rights-of-Way (Curb Ramps)

Main Street: SMOKE\_TREE\_DR Cross Street: SCARLET\_MAPLE\_DR Location: NW

ADA ID: RPAT211102153103 Ramp Type: Type 4 - Parallel Initial Pass/Fail: Fail Overall Compliance: No Severity Score: 15

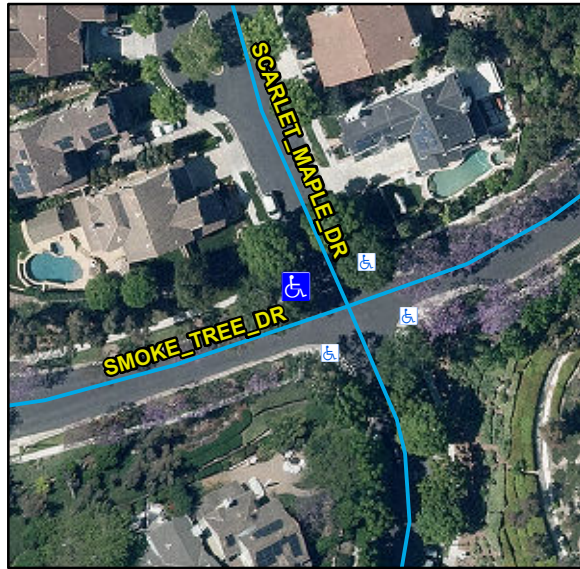
| Compliance | Description | Data | Compliance | Description | Data |
|---|---|---|---|---|---|
| Yes | Ramp Run Slope LT (%) | 2.2 | No | Ramp Run Slope RT (%) | 11.3 |

Remove & Replace Curb Ramp With Two New Directional Ramps or Equivalent.

R204.3, R304.3.2, STD 1115
