# Access Compliance Report Public Rights-of-Way (Curb Ramps)

Main Street: SCARLET\_MAPLE\_DR Cross Street: SMOKE\_TREE\_DR Location: NE

ADA ID: RPAT211102153308 Ramp Type: Type 4 - Parallel Initial Pass/Fail: Fail Overall Compliance: No Severity Score: 32

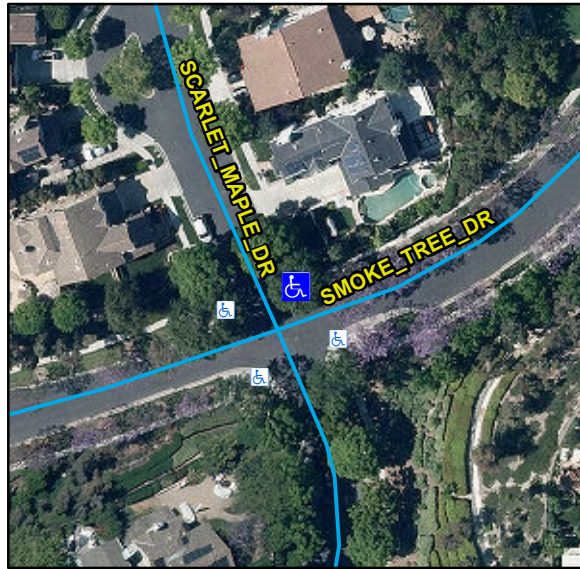
| Compliance | Description | Data | Compliance | Description | Data |
|---|---|---|---|---|---|
| Yes | Ramp Run Slope LT (%) | 4.5 | No | Ramp Run Slope RT (%) | 18 |
| No | Ramp Cross Slope LT (%) | 3.5 | No | Ramp Cross Slope RT (%) | 2.4 |

Remove & Replace Curb Ramp With Two New Directional Ramps or Equivalent.
