# Access Compliance Report Public Rights-of-Way (Curb Ramps)

| Main Street: SMOKE_TREE_DR | | Cross Street: SCARLET_MAPLE_DR | | Location: | SE |
| ADA ID: RPAT211102153732 | Ramp Type: Type 4 - Parallel | Initial Pass/Fail: Fail | Overall Compliance: No | Severity Score: | 32 |

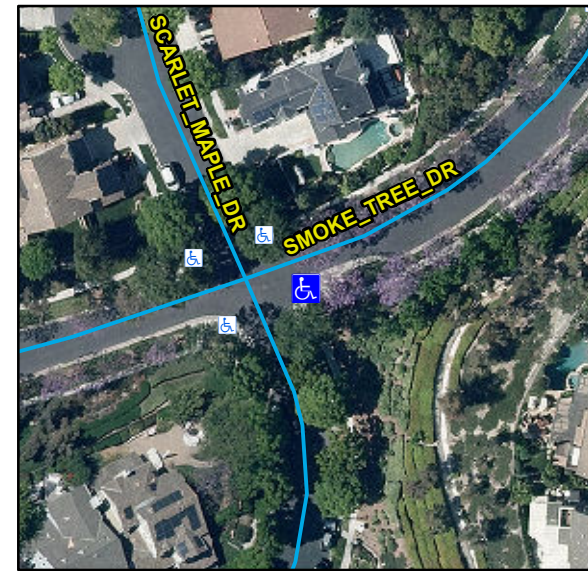
| Compliance | Description | Data | Compliance | Description | Data |
|---|---|---|---|---|---|
| No | Ramp Run Slope LT (%) | 14.4 | Yes | Ramp Run Slope RT (%) | 0.6 |
| No | Ramp Cross Slope LT (%) | 3.6 | No | Ramp Cross Slope RT (%) | 2.8 |

**Remove & Replace Curb Ramp With Two New Directional Ramps or Equivalent.**

**R204.3, R304.3.2, R304.5.3, STD 1115**

Total Cost: \$ 4000
