# Access Compliance Report Public Rights-of-Way (Curb Ramps)

Main Street: CAMERONS\_WAY Cross Street: SMOKE\_TREE\_DR Location: S

ADA ID: RPAT211102154145 Ramp Type: Type 4 - Parallel Initial Pass/Fail: Fail Overall Compliance: No Severity Score: 32

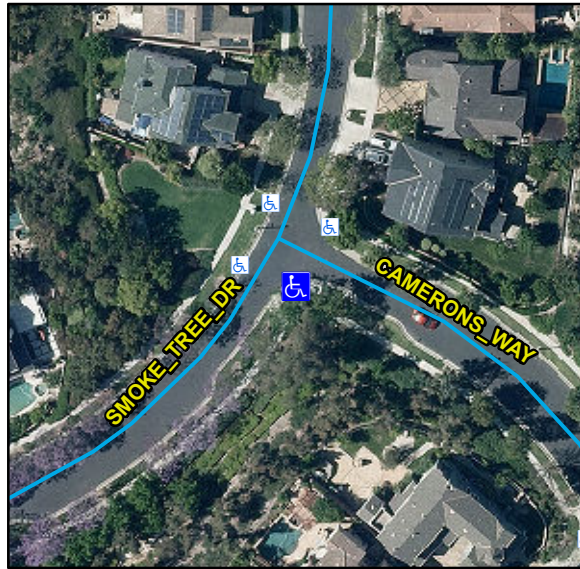
| Compliance | Description | Data | Compliance | Description | Data |
|---|---|---|---|---|---|
| No | Ramp Run Slope LT (%) | 12.7 | Yes | Ramp Run Slope RT (%) | 0.9 |
| No | Ramp Cross Slope LT (%) | 2.2 | Yes | Ramp Cross Slope RT (%) | 1.9 |

Remove & Replace Curb Ramp With Two New Directional Ramps or Equivalent.

R204.3, R304.3.2, R304.5.3, STD 1115
