# Access Compliance Report Public Rights-of-Way (Curb Ramps)

Main Street: CRAFTSBURY\_PL Cross Street: CAMERONS\_WAY Location: NW

ADA ID: RPAT211102154937 Ramp Type: Type 4 - Parallel Initial Pass/Fail: Pass Overall Compliance: No Severity Score: 15

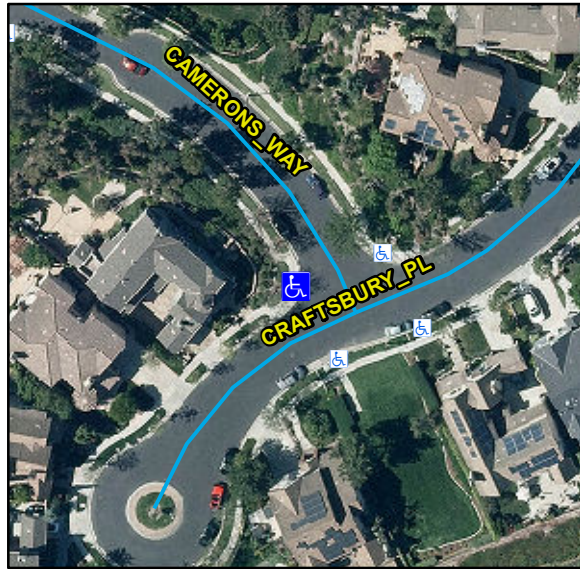
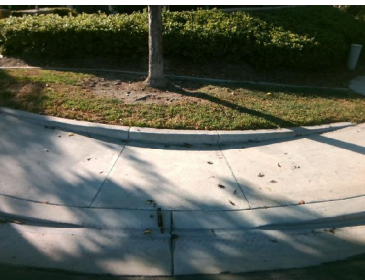
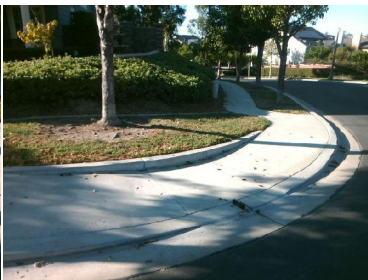
| Compliance | Description | Data | Compliance | Description | Data |
|---|---|---|---|---|---|
| N/A | Landing Present | Yes | No | DWS Provided | No |
| No | Landing Cross Slope (%) | 4.1 | | DWS Offset Type | N/A |
| Yes | Gutter Ponding | No | No | Curb Slope | 10.2 |
| No | Gutter Run Slope (%) | 8.9 | | Road Cross Slope (%) | 1.8 |
| No | Gutter Cross Slope (%) | 3.6 | No | Perpendicular Joint Present | No |

Remove & Replace Curb Ramp With Two New Directional Ramps or Equivalent. Remove & Replace Gutter.

R304.2.2, R204.3, R304.5.3, R305, R304.5.4, STD 1115
