# Access Compliance Report Public Rights-of-Way (Curb Ramps)

Main Street: CAMERONS\_WAY Cross Street: CRAFTSBURY\_PL Location: NE

ADA ID: RPAT211102155509 Ramp Type: Type 4 - Parallel Initial Pass/Fail: Fail Overall Compliance: No Severity Score: 30

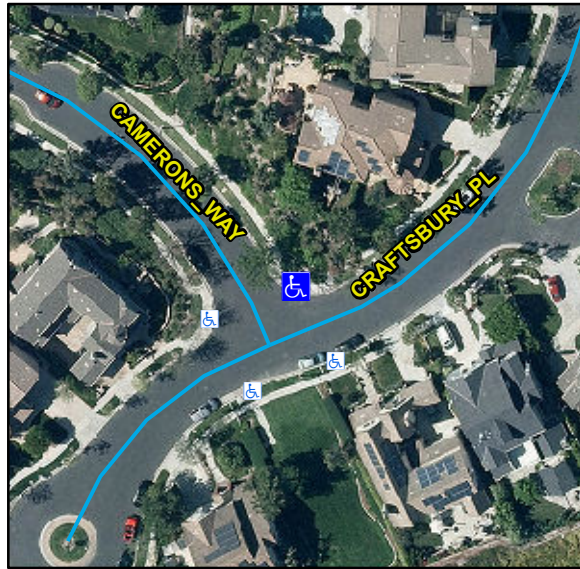
| Compliance | Description | Data | Compliance | Description | Data |
|---|---|---|---|---|---|
| Yes | Ramp Run Slope LT (%) | 0.4 | No | Ramp Run Slope RT (%) | 13.8 |

**Remove & Replace Curb Ramp With Two New Directional Ramps or Equivalent.**

**R204.3, R304.3.2, STD 1115**

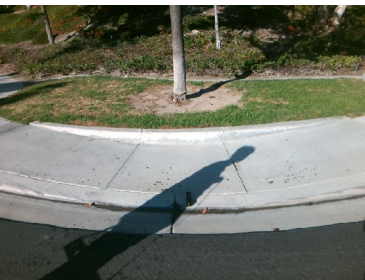
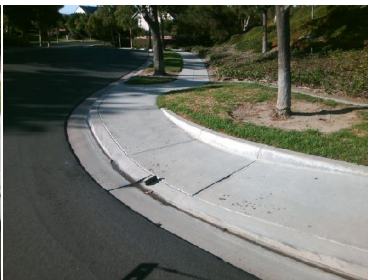
| Compliance | Description | Data | Compliance | Description | Data |
|---|---|---|---|---|---|
| N/A | Gutter Cross Slope (%) | N/A | No | Perpendicular Joint Present | No |
