# Access Compliance Report Public Rights-of-Way (Curb Ramps)

| Main Street: DOWNING_ST | | Cross Street: MARKHAM_LN | | Location: | NW |
| ADA ID: RPAT211103103113 | Ramp Type: Type 4 - Parallel | Initial Pass/Fail: Fail | Overall Compliance: No | Severity Score: | 2 |

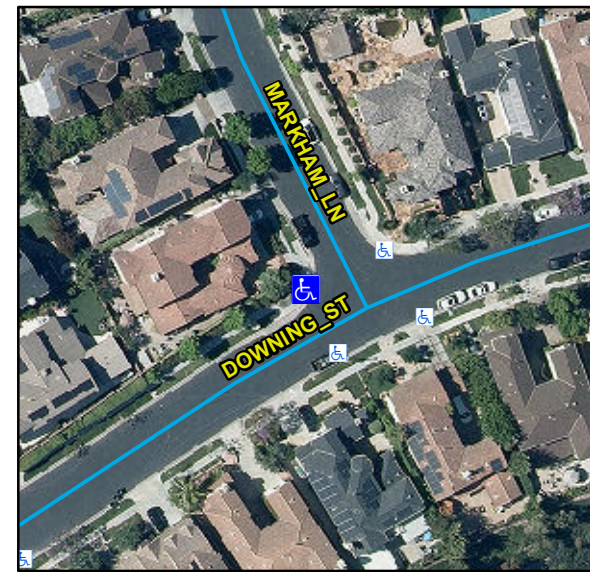
| Compliance | Description | Data | Compliance | Description | Data |
|---|---|---|---|---|---|
| Yes | Ramp Cross Slope LT (%) | 1.7 | No | Ramp Cross Slope RT (%) | 2.8 |
| N/A | Gutter Cross Slope (%) | N/A | No | Perpendicular Joint Present | No |

**Remove & Replace Curb Ramp With Two New Directional Ramps or Equivalent.**

**R204.3, R304.5.3, STD 1115**

Total Cost: \$ 4000
