# Access Compliance Report Public Rights-of-Way (Curb Ramps)

| Main Street: MARKHAM_LN | | Cross Street: DOWNING_ST | | Location: | NE |
| ADA ID: RPAT211103103454 | Ramp Type: Type 4 - Parallel | Initial Pass/Fail: Fail | Overall Compliance: No | Severity Score: | 16 |

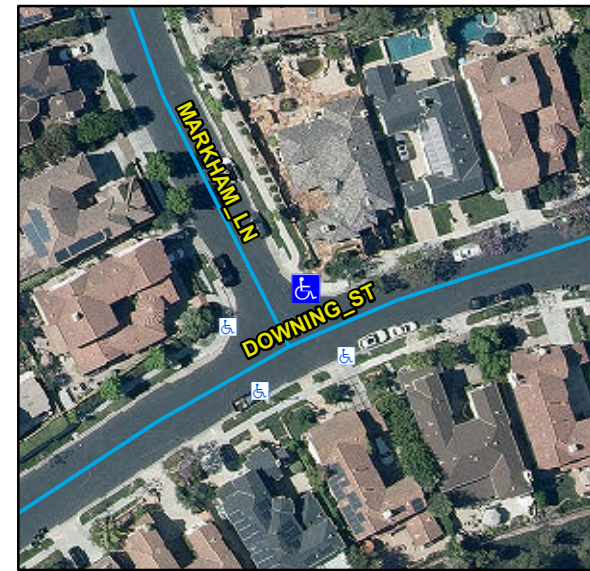
| Compliance | Description | Data | Compliance | Description | Data |
|---|---|---|---|---|---|
| No | Ramp Run Slope LT (%) | 8.9 | Yes | Ramp Run Slope RT (%) | 4.6 |
| Yes | Ramp Cross Slope LT (%) | 1.1 | No | Ramp Cross Slope RT (%) | 4.3 |

Possible Solutions:

**Remove & Replace Curb Ramp With Two New Directional Ramps or Equivalent.**

**R204.3, R304.3.2, R304.5.3, STD 1115**

Total Cost: \$ 4000
