# Access Compliance Report Public Rights-of-Way (Curb Ramps)

| Main Street: VINEYARD_RD | | Cross Street: DOWNING_ST | | Location: | NE |
| ADA ID: RPAT211103103953 | Ramp Type: Type 4 - Parallel | Initial Pass/Fail: Fail | Overall Compliance: No | Severity Score: | 2 |

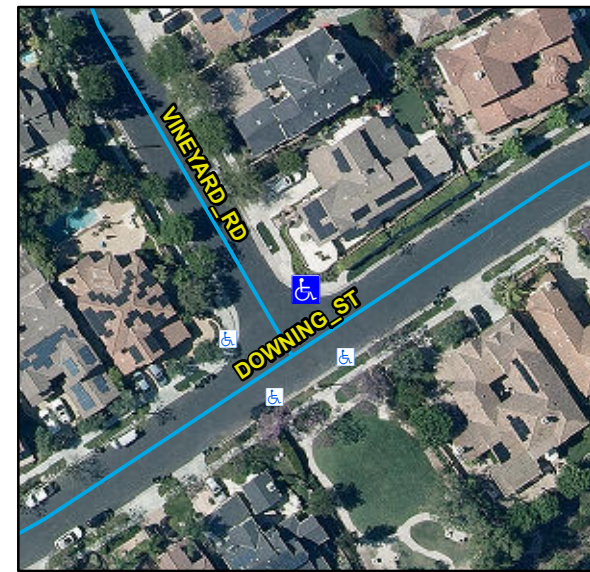
| Compliance | Description | Data | Compliance | Description | Data |
|---|---|---|---|---|---|
| No | Ramp Cross Slope LT (%) | 2.5 | No | Ramp Cross Slope RT (%) | 2.3 |

**Remove & Replace Curb Ramp With Two New Directional Ramps or Equivalent.**

**R204.3, R304.5.3, STD 1115**

Total Cost: \$ 4000
