# Access Compliance Report Public Rights-of-Way (Curb Ramps)

| Main Street: DOWNING_ST | | Cross Street: VINEYARD_RD | | Location: | NW |
| ADA ID: RPAT211103104339 | Ramp Type: Type 4 - Parallel | Initial Pass/Fail: Fail | Overall Compliance: No | Severity Score: | 16 |

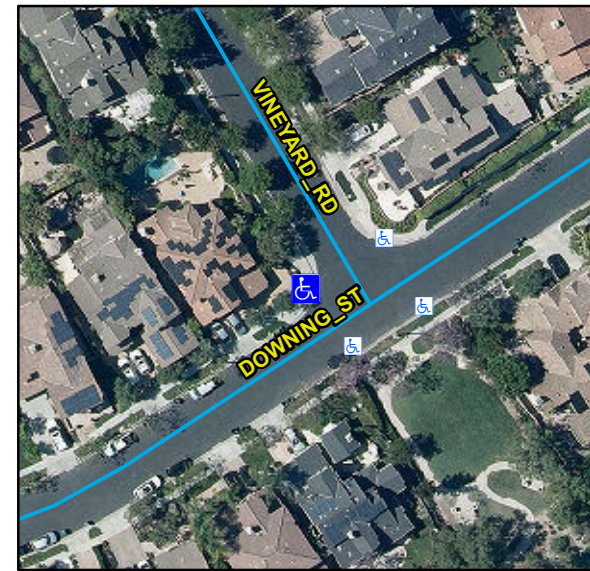
| Compliance | Description | Data | Compliance | Description | Data |
|---|---|---|---|---|---|
| Yes | Ramp Run Slope LT (%) | 1.5 | No | Ramp Run Slope RT (%) | 10.5 |
| No | Ramp Cross Slope LT (%) | 2.3 | Yes | Ramp Cross Slope RT (%) | 1.6 |

**Remove & Replace Curb Ramp With Two New Directional Ramps or Equivalent.**

**R204.3, R304.5.3, R304.3.2, STD 1115**

Total Cost: \$ 4000
