# Access Compliance Report Public Rights-of-Way (Curb Ramps)

Main Street: CHARDONNAY\_DR Cross Street: DOWNING\_ST Location: SE

ADA ID: RPAT211103105027 Ramp Type: Type 4 - Parallel Initial Pass/Fail: Pass Overall Compliance: No Severity Score: 15

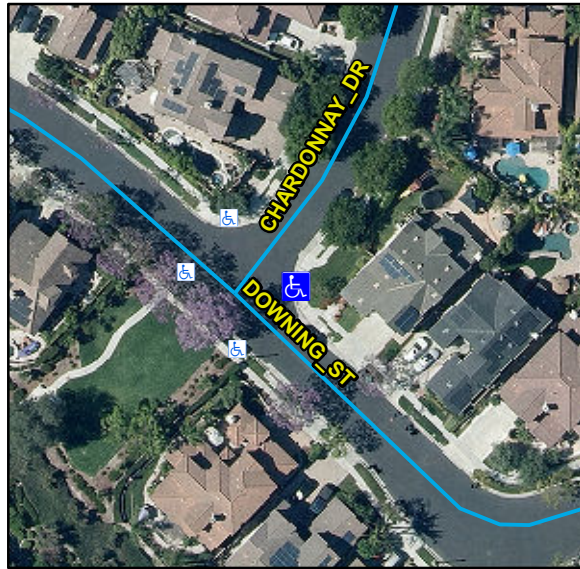
| Compliance | Description | Data | Compliance | Description | Data |
|---|---|---|---|---|---|
| N/A | Landing Present | Yes | No | DWS Provided | No |
| Yes | Gutter Ponding | No | No | Curb Slope | 10.9 |
| No | Gutter Run Slope (%) | 5.6 | | Road Cross Slope (%) | 1 |
| No | Gutter Cross Slope (%) | 4.3 | No | Perpendicular Joint Present | No |

Remove & Replace Curb Ramp With Two New Directional Ramps or Equivalent. Remove & Replace Gutter.

R304.2.2, R204.3, R305, R304.5.4, R304.5.3, STD 1115
