# Access Compliance Report Public Rights-of-Way (Curb Ramps)

| Main Street: SAUVIGNON_DR | | Cross Street: CHARDONNAY_DR | | Location: | S |
| ADA ID: RPAT211103105959 | Ramp Type: Type 4 - Parallel | Initial Pass/Fail: Fail | Overall Compliance: No | Severity Score: | 15 |

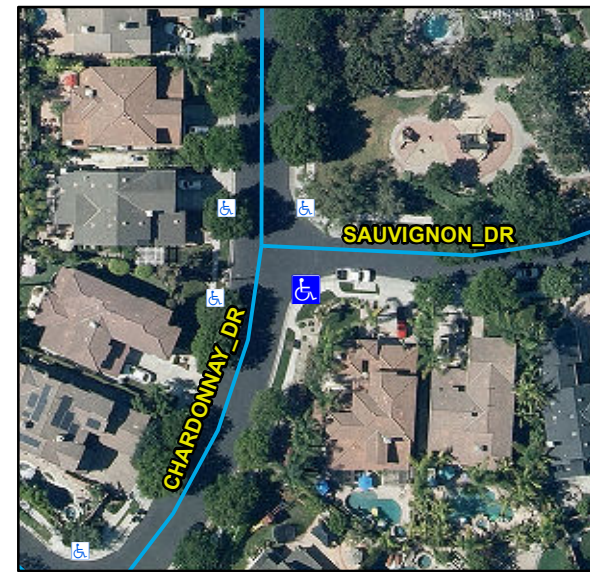
| Compliance | Description | Data | Compliance | Description | Data |
|---|---|---|---|---|---|
| No | Ramp Run Slope LT (%) | 8.5 | Yes | Ramp Run Slope RT (%) | 3.5 |

Possible Solutions:

**Remove & Replace Curb Ramp With Two New Directional Ramps or Equivalent.**

**R204.3, R304.3.2, STD 1115**

Total Cost: \$ 4000
