# Access Compliance Report Public Rights-of-Way (Curb Ramps)

Main Street: CHARDONNAY\_DR Cross Street: SAUVIGNON\_DR Location: NE

ADA ID: RPAT211103110248 Ramp Type: Type 4 - Parallel Initial Pass/Fail: Fail Overall Compliance: No Severity Score: 2

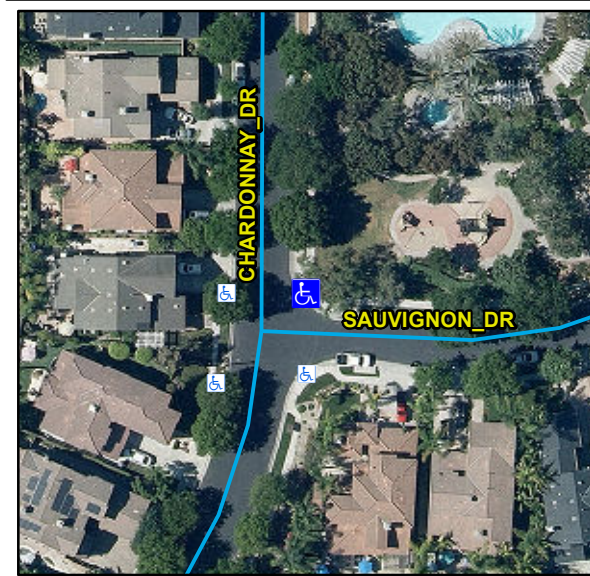
| Compliance | Description | Data | Compliance | Description | Data |
|---|---|---|---|---|---|
| Yes | Ramp Run Slope LT (%) | 7.5 | Yes | Ramp Run Slope RT (%) | 0.5 |
| No | Ramp Cross Slope LT (%) | 2.7 | No | Ramp Cross Slope RT (%) | 4.2 |

Possible Solutions:

**Remove & Replace Curb Ramp With Two New Directional Ramps or Equivalent.**

**R204.3, R304.5.3, STD 1115**

Total Cost: \$ 4000
