# Access Compliance Report Public Rights-of-Way (Curb Ramps)

Main Street: SAUVIGNON\_DR Cross Street: VINEYARD\_RD Location: NW

ADA ID: RPAT211103110743 Ramp Type: Type 4 - Parallel Initial Pass/Fail: Fail Overall Compliance: No Severity Score: 30

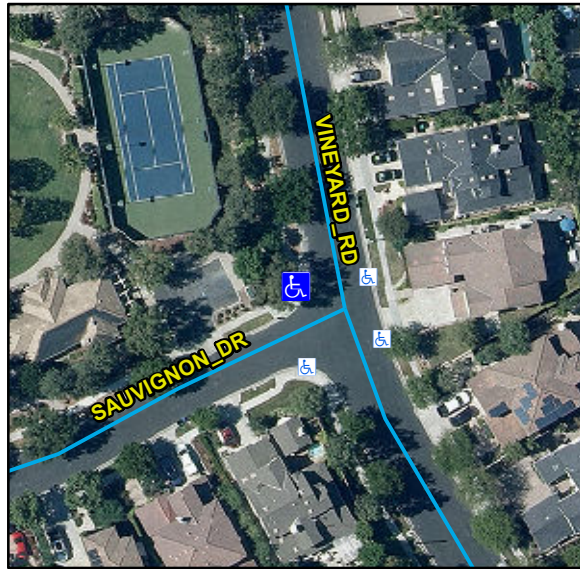
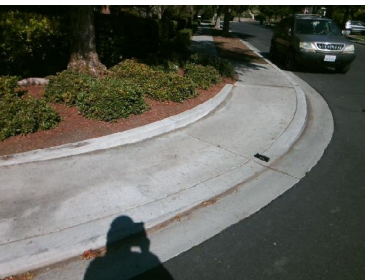
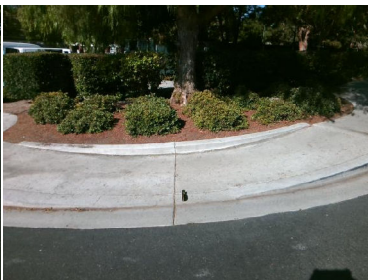
| Compliance | Description | Data | Compliance | Description | Data |
|---|---|---|---|---|---|
| Yes | Ramp Run Slope LT (%) | 1.9 | No | Ramp Run Slope RT (%) | 13.3 |

**Remove & Replace Curb Ramp With Two New Directional Ramps or Equivalent.**

**R204.3, R304.3.2, STD 1115**
