# Access Compliance Report Public Rights-of-Way (Curb Ramps)

Main Street: VINEYARD\_RD Cross Street: SAUVIGNON\_DR Location: SW

ADA ID: RPAT211103111029 Ramp Type: Type 4 - Parallel Initial Pass/Fail: Pass Overall Compliance: No Severity Score: 15

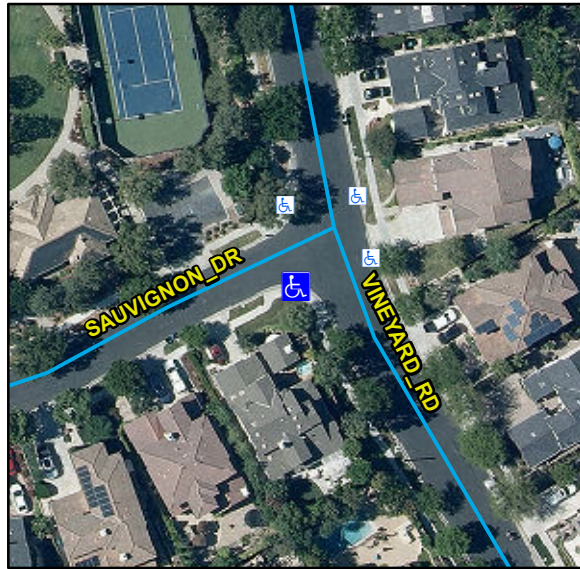
R204.3, R305, R304.5.4, STD 1115

Remove & Replace Curb Ramp With Two New Directional Ramps or Equivalent. Remove & Replace Gutter.
