# Access Compliance Report Public Rights-of-Way (Curb Ramps)

| Main Street: ROANOKE_DR | | Cross Street: VINEYARD_RD | | Location: | SE |
| ADA ID: RPAT211103111555 | Ramp Type:Type 1 - Perpendicular Diagonal Initial Pass/Fail: Fail | | Overall Compliance: No | Severity Score: | 30 |

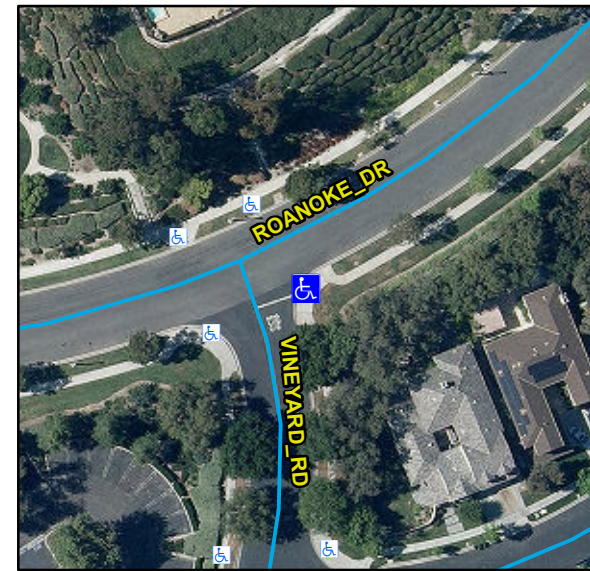
| Compliance | Description | Data | Compliance | Description | Data |
|---|---|---|---|---|---|
| No | Ramp Cross Slope (%) | 9 | N/A | Flare Traversable LT | N/A |

Possible Solutions:

**Remove & Replace Curb Ramp With Two New Directional Ramps or Equivalent.**

**R304.2.2, R204.3, R304.5.3, STD 1115**

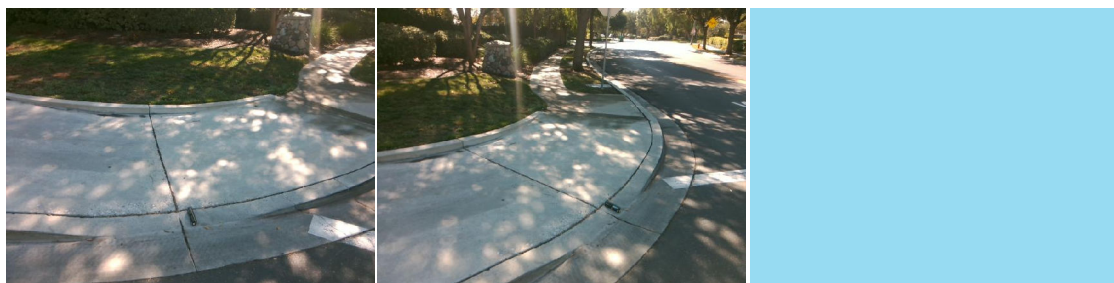
| Compliance | Description | Data | Compliance | Description | Data |
|---|---|---|---|---|---|
| N/A | Gutter Ponding | N/A | No | Curb Slope | 13.1 |
